## Indoor Environmental Quality Assessment

EXAMPLE ASSESSMENT REPORT

Ridgeway Professional Center  
Asheville, North Carolina

IES-EXAMPLE-001

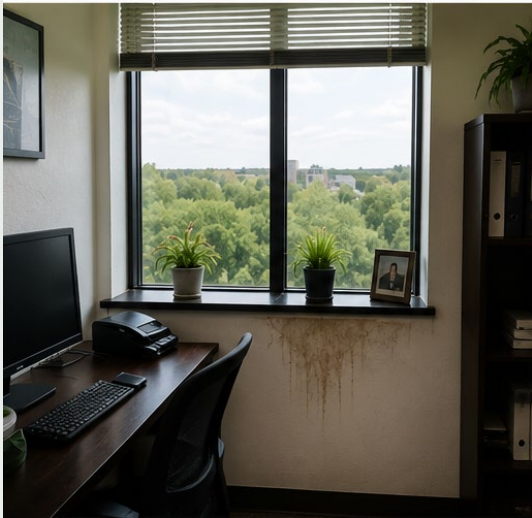
LOCATION ID IEQ-01 | CONDITION TYPE Moisture-related finish deterioration

**FIELD CONTEXT**  
The example condition is located beneath an exterior window assembly along the perimeter wall of an occupied office. The area was selected to demonstrate how IES links a documented condition to a specific location and follow-up action.

Discoloration and finish deterioration are documented beneath the windowsill and along the gypsum wallboard surface. The example condition is visually consistent with prior moisture exposure. No active dripping or standing water is depicted at the time of the assessment.

**INTERPRETATION**  
The documented finish deterioration and relative moisture-screening response are consistent with historical or intermittent moisture exposure in the vicinity of the window assembly. These observations do not, by themselves, establish the concealed source or full extent of moisture-affected materials.

Evaluate the exterior window assembly and adjacent interfaces for a potential moisture-entry pathway. After the source is corrected, assess affected finish materials for appropriate cleaning, repair, or removal. Continue to observe the area for evidence of recurring moisture.

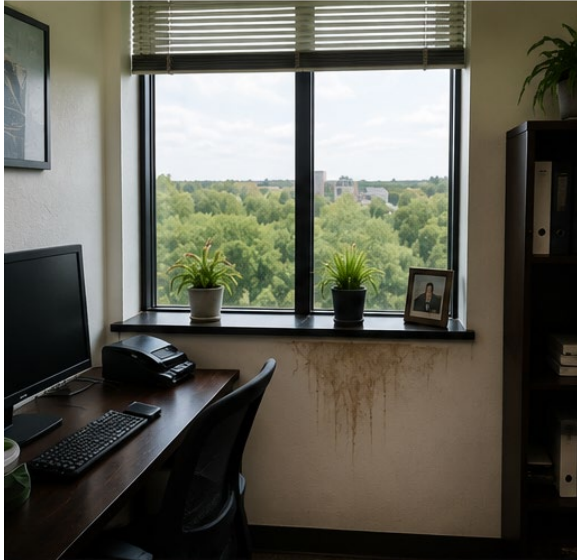
IEQ-01A · CONTEXT Perimeter office

**OBSERVATION Overall** view of the exterior-wall office area showing the window assembly and interior finishes.

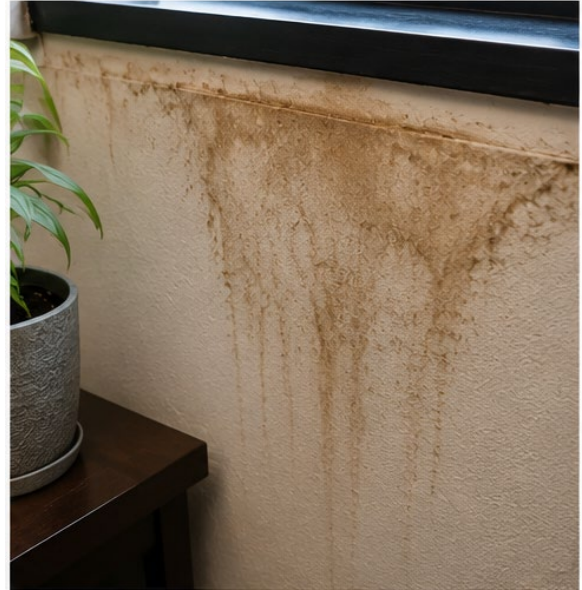
IEQ-01B · DETAIL Below windowsill

**OBSERVATION Closer** view of localized discoloration and finish deterioration beneath the windowsill.

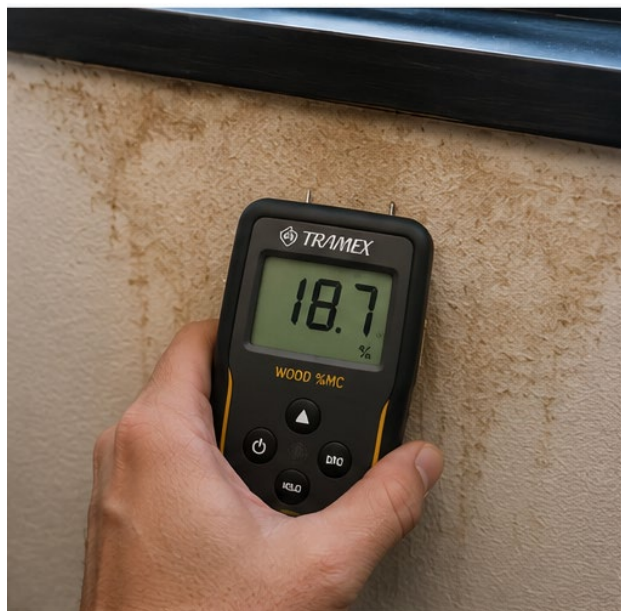
IEQ-01C · MEASUREMENT LOCATION Adjacent wall finish

| Surface Moisture Screening | Elevated relative to adjacent dry comparison area |

**OBSERVATION Location** is used to document comparative surface-moisture screening near the visibly affected finish.

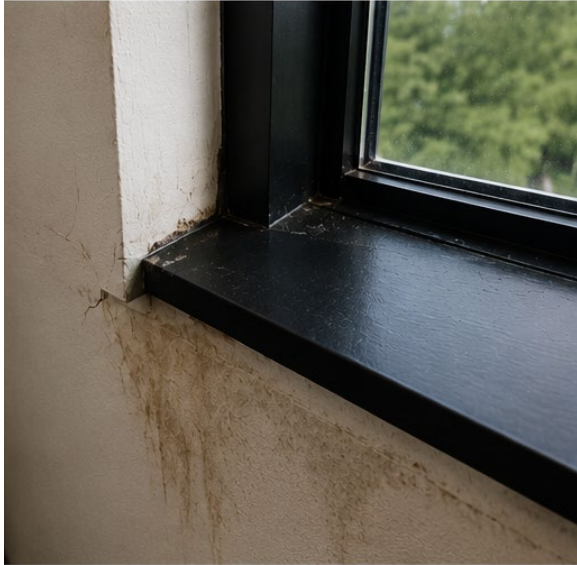
**IEQ-01D · INTERFACE DETAIL** Window perimeter

**OBSERVATION** Close-up of the window-to-wall interface documented for evaluation of a potential moisture-entry pathway.

- Evaluate the exterior window assembly, perimeter sealants, flashing, and adjacent interfaces for a moisture-entry pathway.
- Repair the identified source before completing cosmetic restoration.
- Evaluate affected finish materials and clean, repair, or remove materials as appropriate to their condition and project requirements.
- Use qualified contractors where the scope of work, material type, or regulatory requirements warrant specialized services.

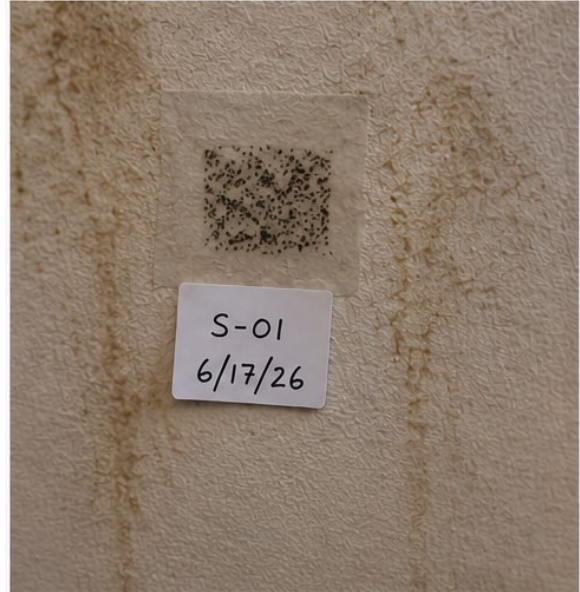
**IEQ-01E · SAMPLE LOCATION** Below windowsill

| Sample ID | Location | Type | Example Result |
|---|---|---|---|
| S-01 | Below windowsill | Tape lift | Moderate fungal structures observed; Cladosporium-type predominant |

**OBSERVATION Surface** tape-lift sample collection location associated with the localized finish condition.

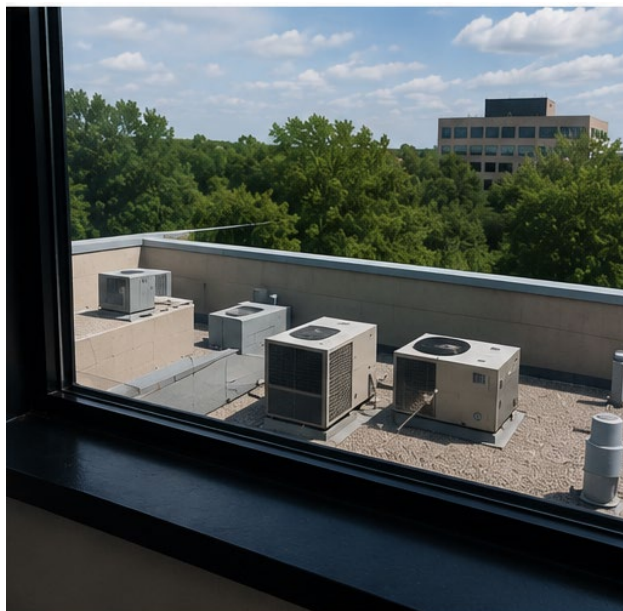
**IEQ-01F · REFERENCE VIEW** Perimeter office

**OBSERVATION Overall** reference view retained to support future comparison after corrective work or follow-up observation.
